**Hillslope and Fluvial Processes Along the
Proposed Pipeline Corridor,
Burns Lake to Kitimat,
West Central British Columbia**

James W. Schwab P.Geo., Eng.L.

Bulkley Valley Centre for Natural Resources

Prepared: September, 2011

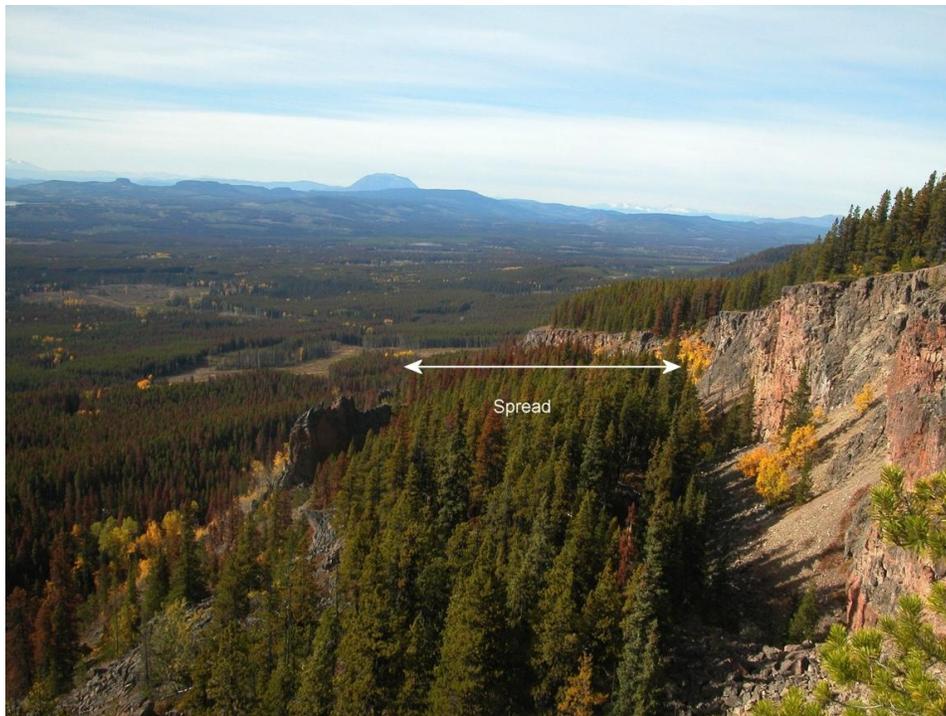
Figure 4: Bedrock spread located east of Parrott Creek. The overlaying volcanic bedrock has split apart and is slowly moving away from the scarp along a deeper surface of much older volcanic bedrock.

Bedrock spread, a form of landslide movement, is active along the ridge above Parrott Creek within the general corridor for the pipelines (Figure 4). Geertsema et al. (2009) mentions these landslides but they remain unstudied. Bedrock geology along the ridge above Parrott Creek is an important factor in the instability of the ridge; it comprises flat and gently dipping lava that covers much older volcanic, sedimentary and intrusive rocks (Tipper and Richards 1976). The spread of upper bedrock layers on older rocks may continue gradually over a long period or may reach a point of catastrophic failure sometime in the future (Figure 5). The active bedrock spread occurring along the ridge near Parrott Creek may be an indication or foreshadowing of further movement at other locations along these ridges.

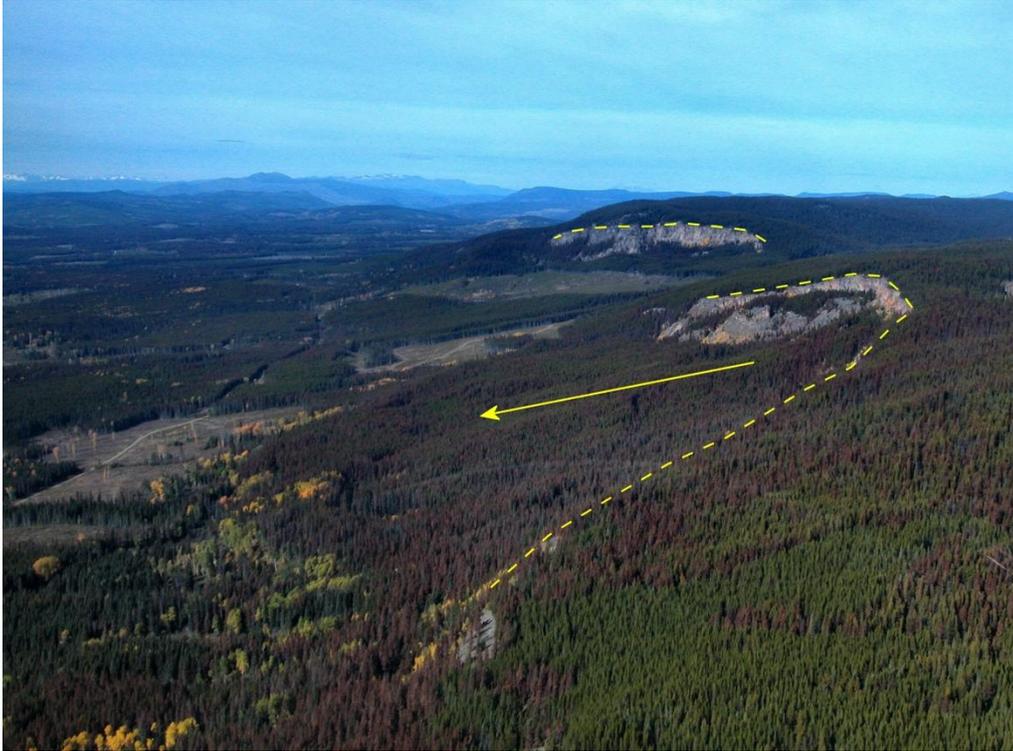
Figure 5: Bedrock spread lead to catastrophic landslides along a 2.5 km scarp (photo lower centre to upper right) and a 1.3 km scarp (photo distance) on the ridge above Parrott Creek. The landslides involved up to 150 and 50 Mm³ of material, respectively. The yellow dashed line delineates the landslides' headscarp. The arrow shows the direction of movement.

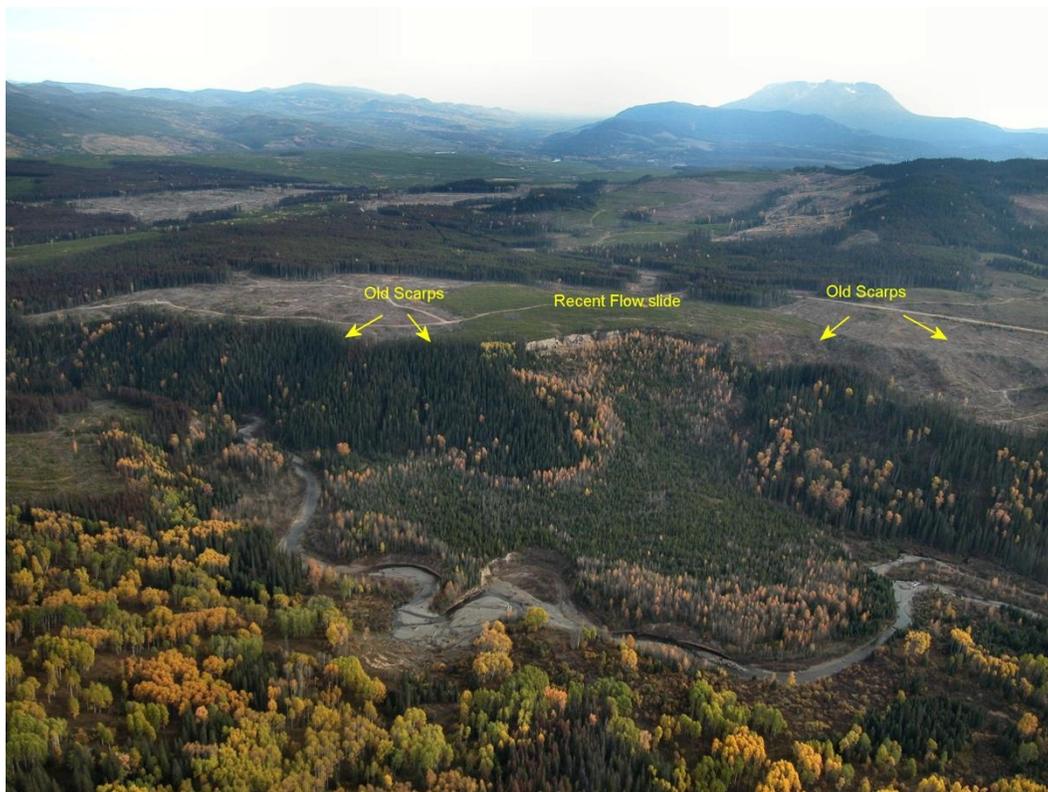
Figure 6: A low gradient flow slide in advance-phase glaciolacustrine sediment at Houston Tommy Creek. Older landslide scarps are indicated with arrows.

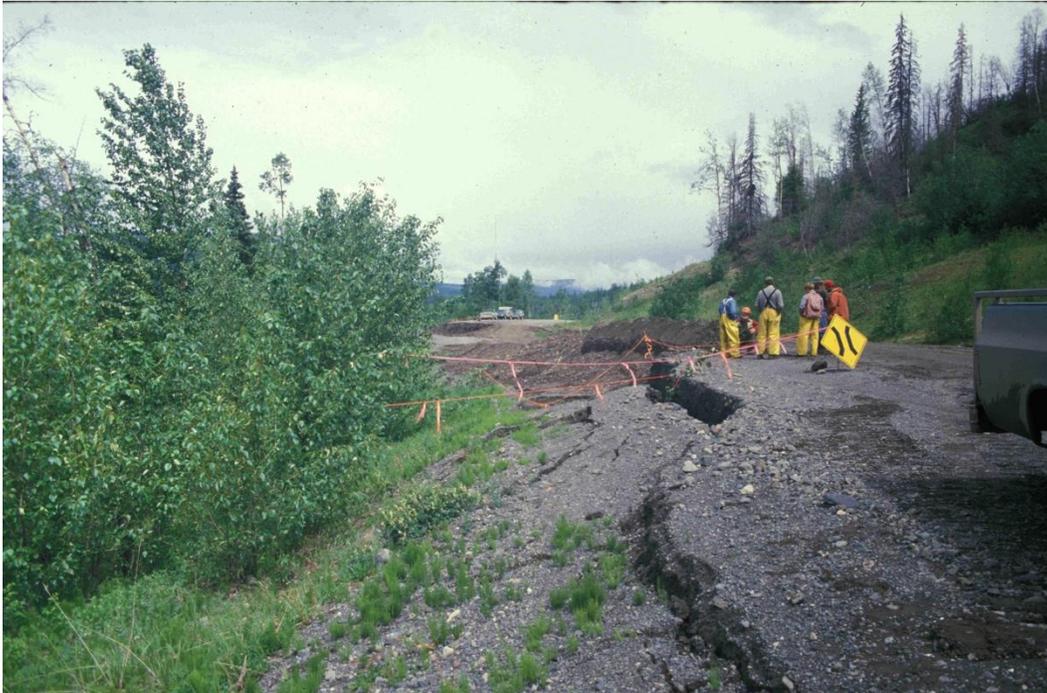
Figure 7: A reactivated slump earth flow after an up-grade of the Morice Road. Attempts to stabilize the road have cost millions of dollars over the past 30 years.

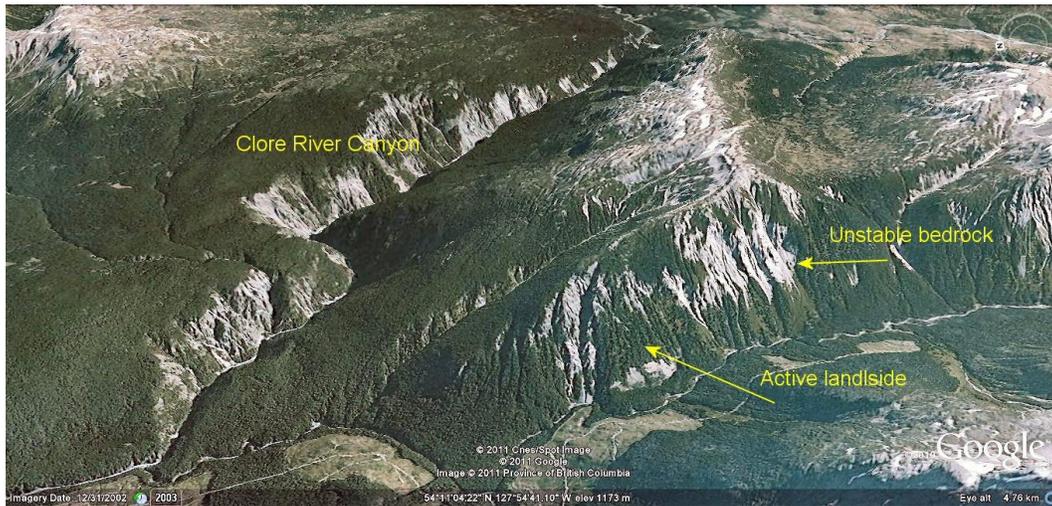
Figure 9: Google Earth image looking east from the general location of Nimbus Mountain. The volcanic bedrock below 1200 masl is unstable and extensively gullied with visible landslide scarps and void of trees. The large active landslide is pushing the creek across the valley.

The proposed Clore tunnel connects the Clore basin above the canyon through to a tributary stream of the Clore at the base of Nimbus Mountain—a distance of about 7 km. Tipper and Richards (1976) show a complex array of faults near the Clore Canyon—these faults are readily discerned on aerial photographs (BC 88038 164–167). The bedrock in the canyon is highly fractured and deeply weathered. Unstable bedrock reaches up to 1200 masl or possibly 1400 masl and extends around the mountain into the adjacent tributary valley. The central core of the mountain is probably quartz diorite; however, the volcanic bedrock at mid and lower elevations is extensively gullied with visible landslide scarps. A large distinct landslide feature located on the west shoulder appears to be actively moving, deflecting the creek across the valley (Figure 9). A series of large cirque shaped landslide scarps sit at about 1400 masl with deep gullies connecting down to the Clore River Canyon. Lineations, probably sackungen, indicative of active slope movement extend across the hillslope through the landslide scarps (Figure 10). Clusters of smaller landslide scarps sit along and down the west

shoulder of the mountain. The instability of the volcanic rock on this hillslope will place major constraints on pipeline development.

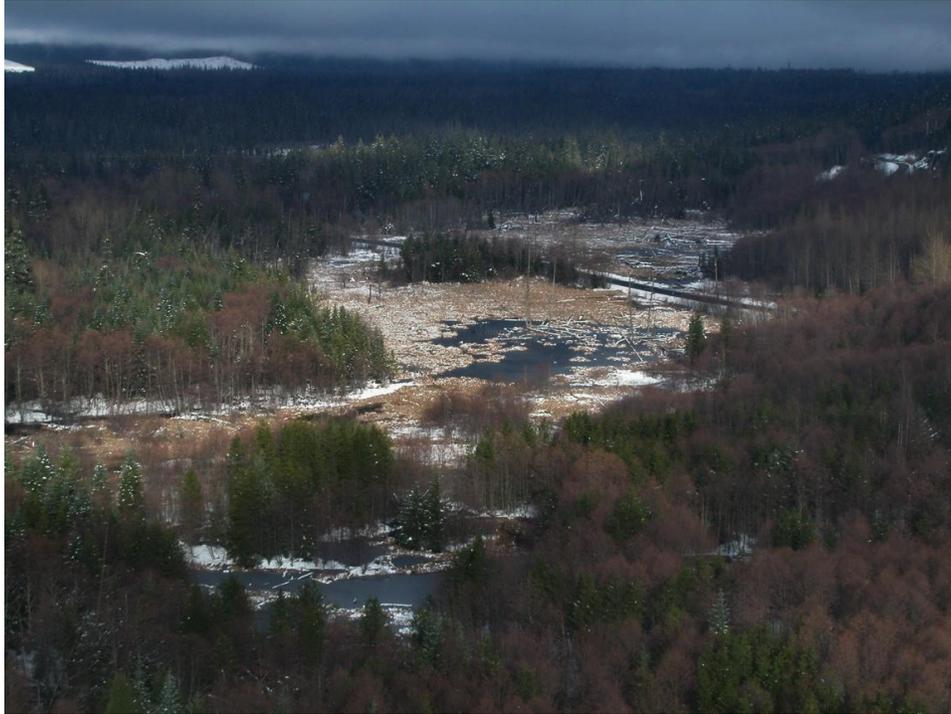
Figure 13: This large swampy area is the location of the May 1962 Lakelse flow slide. Highway 37 crosses the landslide depletion zone. The Provincial Park is located middle left of the photo.

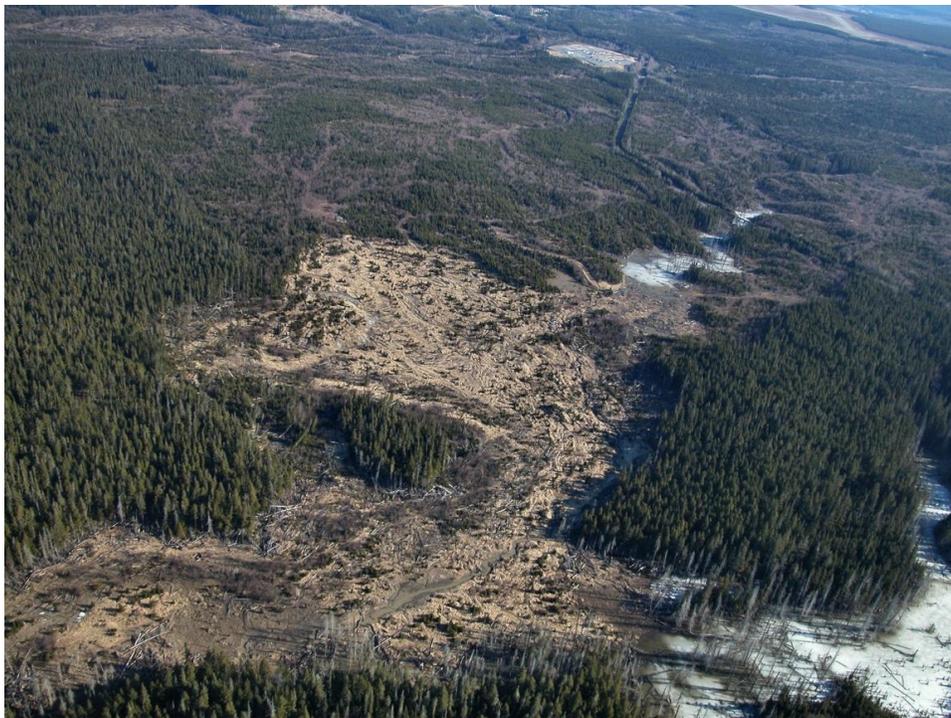
Figure 14: The Mink Creek flow slide rapidly retrogressed along a slope of about 3°, approximately 23 ha flowed into Mink Creek, extending downstream for 1 km.

- A landslide occurred sometime between mid December 1993 and early January 1994 into Mink Creek, a tributary of Lakelse River (Geertsema and Schwab 1995; Geertsema and Schwab 1996; Geertsema 2004; Geertsema and Torrance 2005; Geertsema et al. 2006b). The landslide likely started as a small failure along the creek that exposed sensitive clays in the cut bank. Once the sensitive materials were exposed, the landslide rapidly retrogressed along a slope of about 3°. About 23 ha slid and flowed into Mink Creek, filling the channel, extending downstream for about 1 km. Debris dammed the creek, raised water levels by 10 m and backed water up stream for 1200 m (Figure 14).

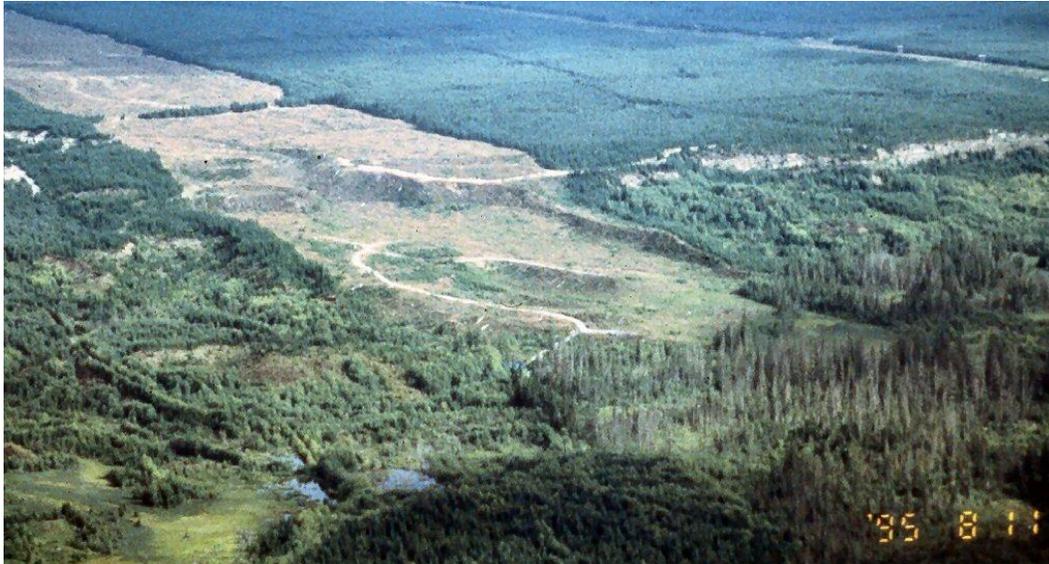
Figure 15: Foreslope of the Onion Lake Flats (fan-delta) to the east of Cecil Creek. Roads follow arcuate ridges that outline prehistoric flow slides. The ridges are visible in the clearcut (photo centre) and in the area reforested (photo centre-left).
